STUDY OF CONVENTIONAL TILE FIELDS IN FINE - GRAINED SOILS

REPORT NO. 74

December 1978

Applied Sciences Section
Pollution Control Branch
Ontario Ministry of the Environment

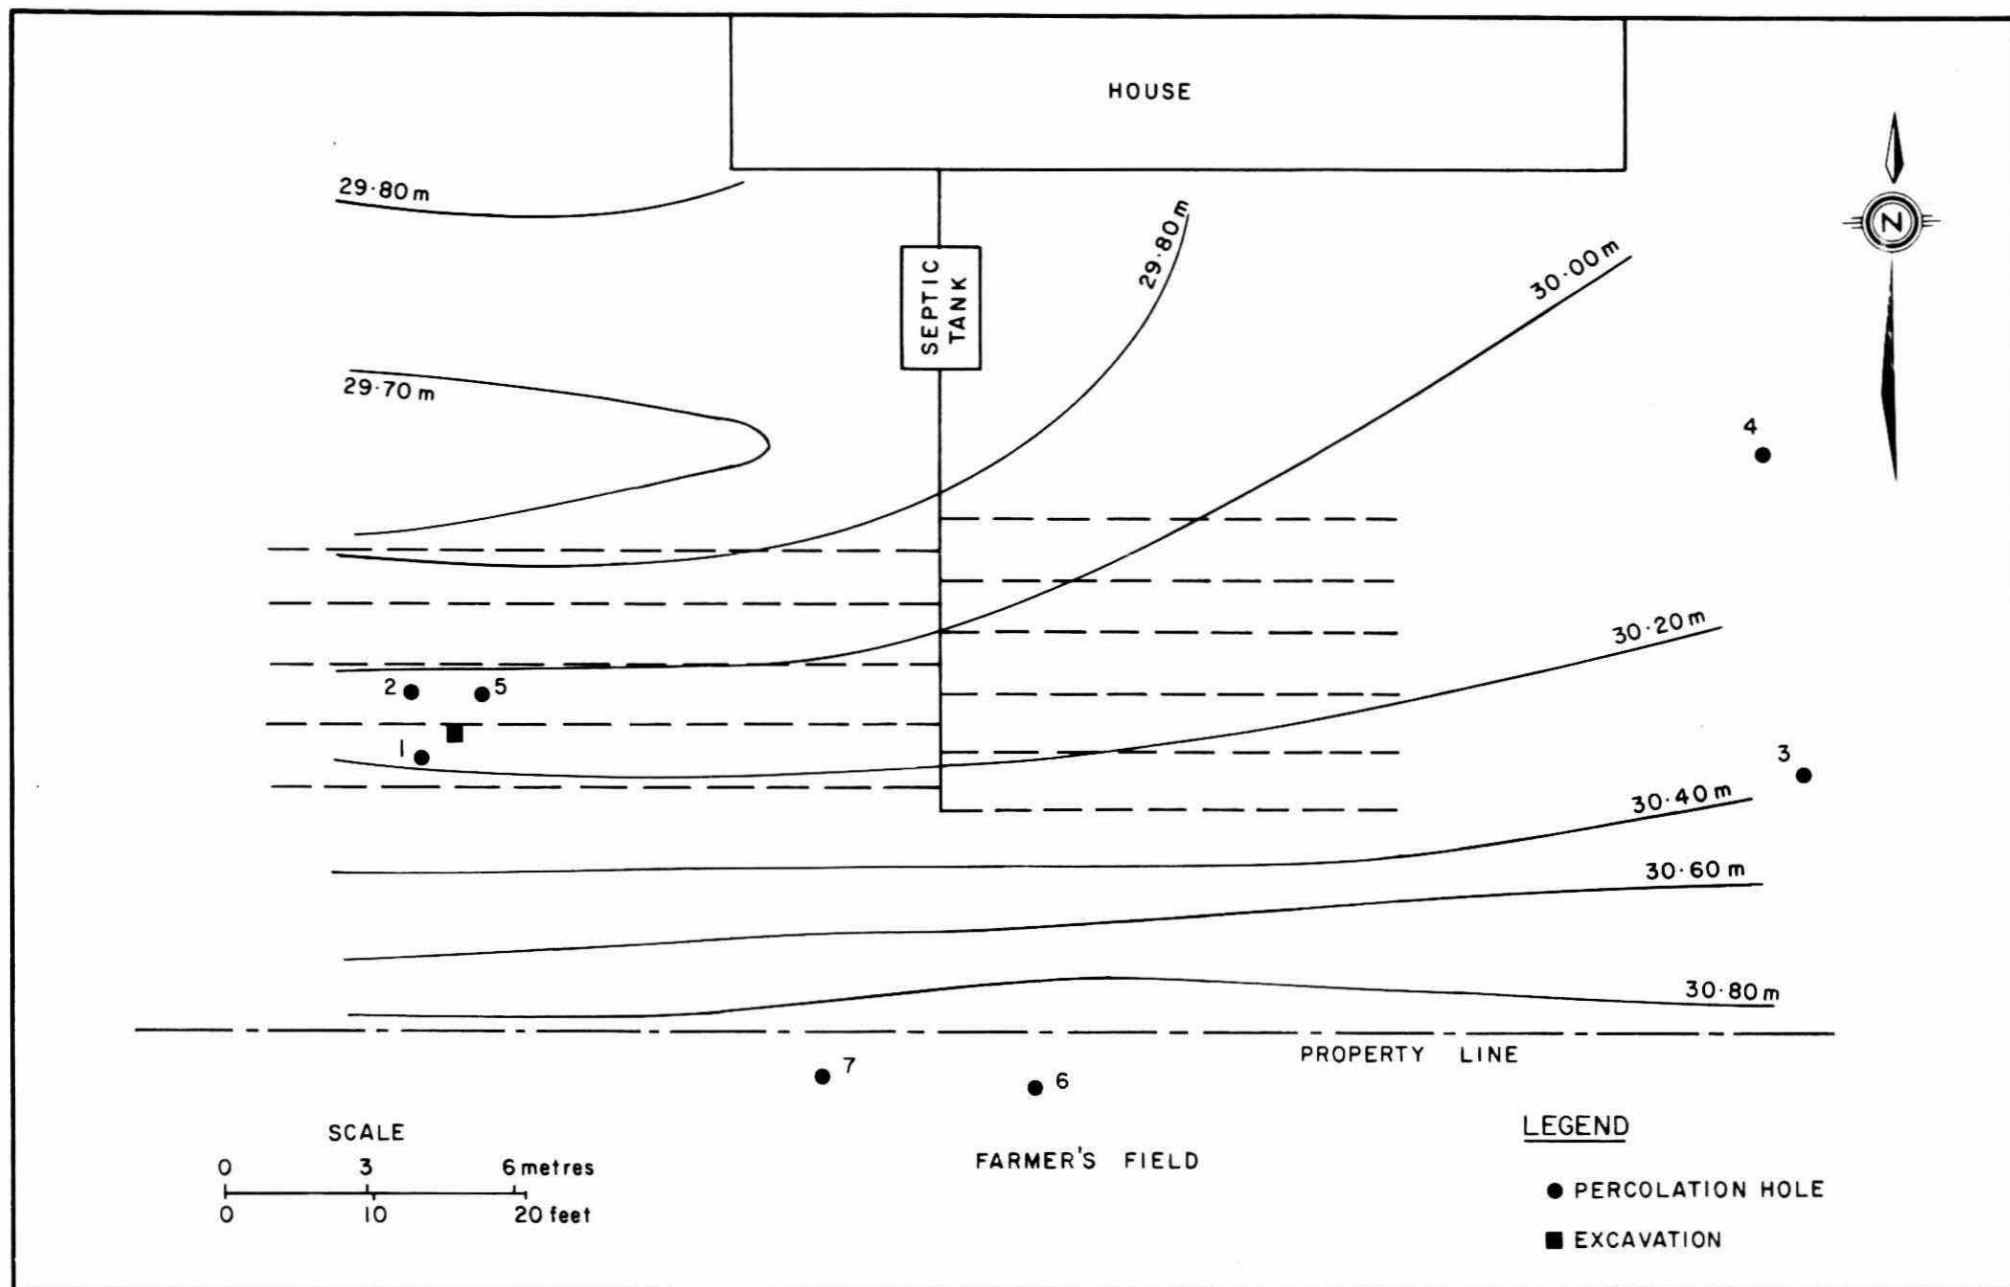
FIGURE 4: LAYOUT, TOPOGRAPHY AND LOCATIONS OF PERCOLATION HOLES AT SITE A1.

A total of five percolation holes were dug in or near the tile field area (Holes 1 to 5 as shown in Figure 4) and six tests were done in the spring season of 1976. Test results are presented in Table 1, which indicate that the percolation time of the soil was not greater than 24 min/cm (60 min/in.). Also, the percolation time at the depth of 0.9 m (3 ft.) was larger than that at the depth of 0.6 m (2 ft.). This was probably because the soil at the shallower depth had more hair-line cracks and fissures as a result of weathering or worm holes.

During many visits to the site in different seasons in 1976 and 1977, the ground surface of the tile field was visually examined for signs of surface ponding. It was found that the system was quite satisfactory.

In summary, it can be concluded that the soil in the tile field had adequate absorptive capacity for the septic tank effluent. The main factors contributing to this operational success were: (i) favourable soil drainage characteristics (percolation time less than 24 min./cm), (ii) low hydraulic loading rate ($15.7 \text{ L/m}^2/\text{d}$), and (iii) good surface drainage condition (i.e. surface water drainage away from the tile field area).

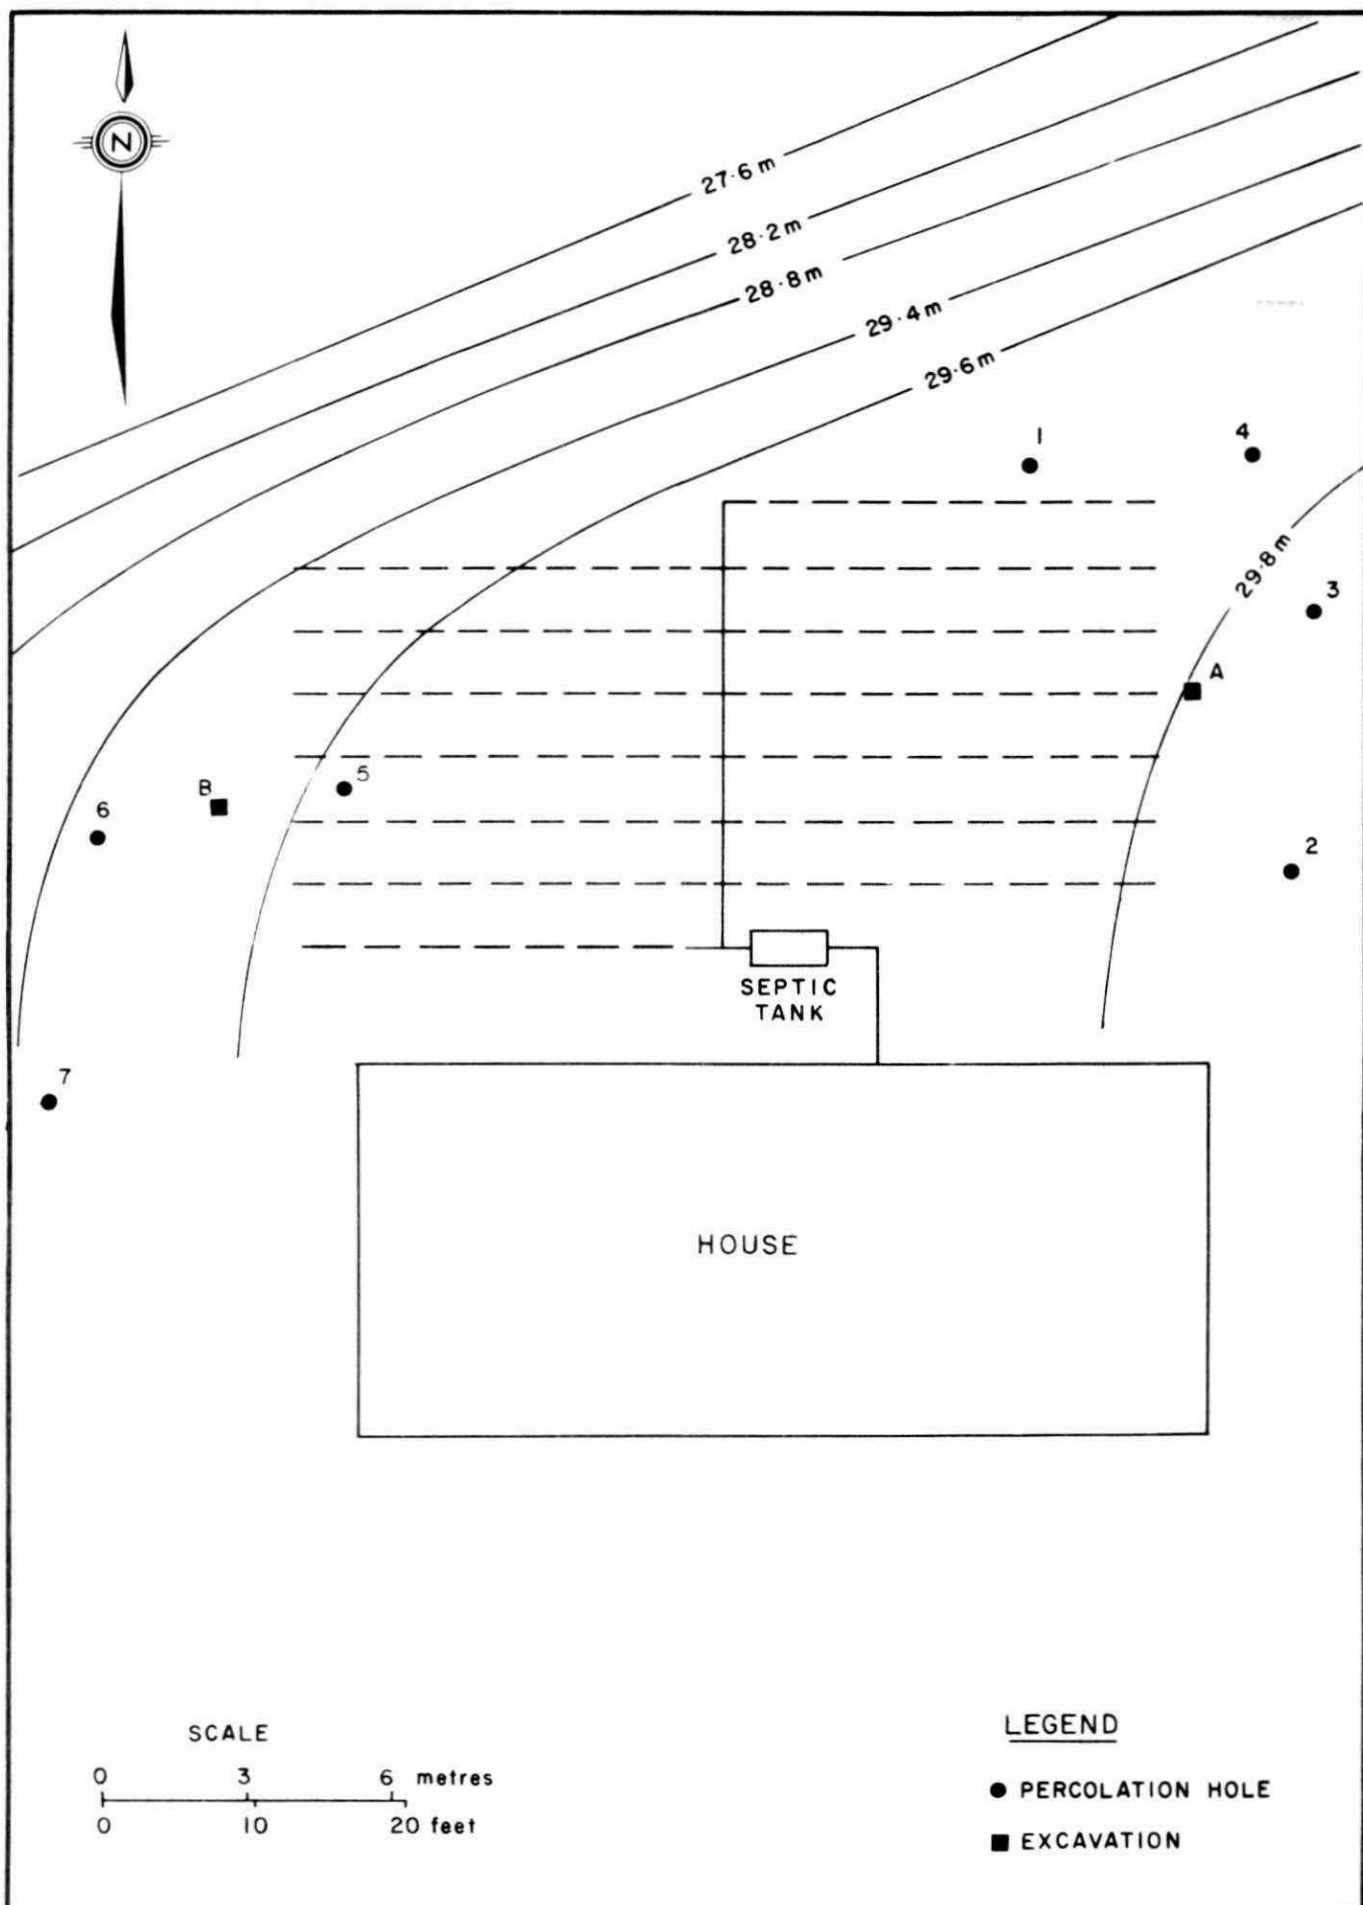
FIGURE 5 : LAYOUT, TOPOGRAPHY AND LOCATIONS OF PERCOLATION HOLES
AT SITE A2

It is of practical interest to note that the performance of the tile field was satisfactory even though the percolation time of the soil exceeded 24 min./cm (60 min./in.). Furthermore, it was found that the soil at the shallower depth had a larger percolation time than the similar soil at greater depth. This may be explained by the fact that the soil at the shallower depth was a fill material and was disturbed and remoulded by compaction.

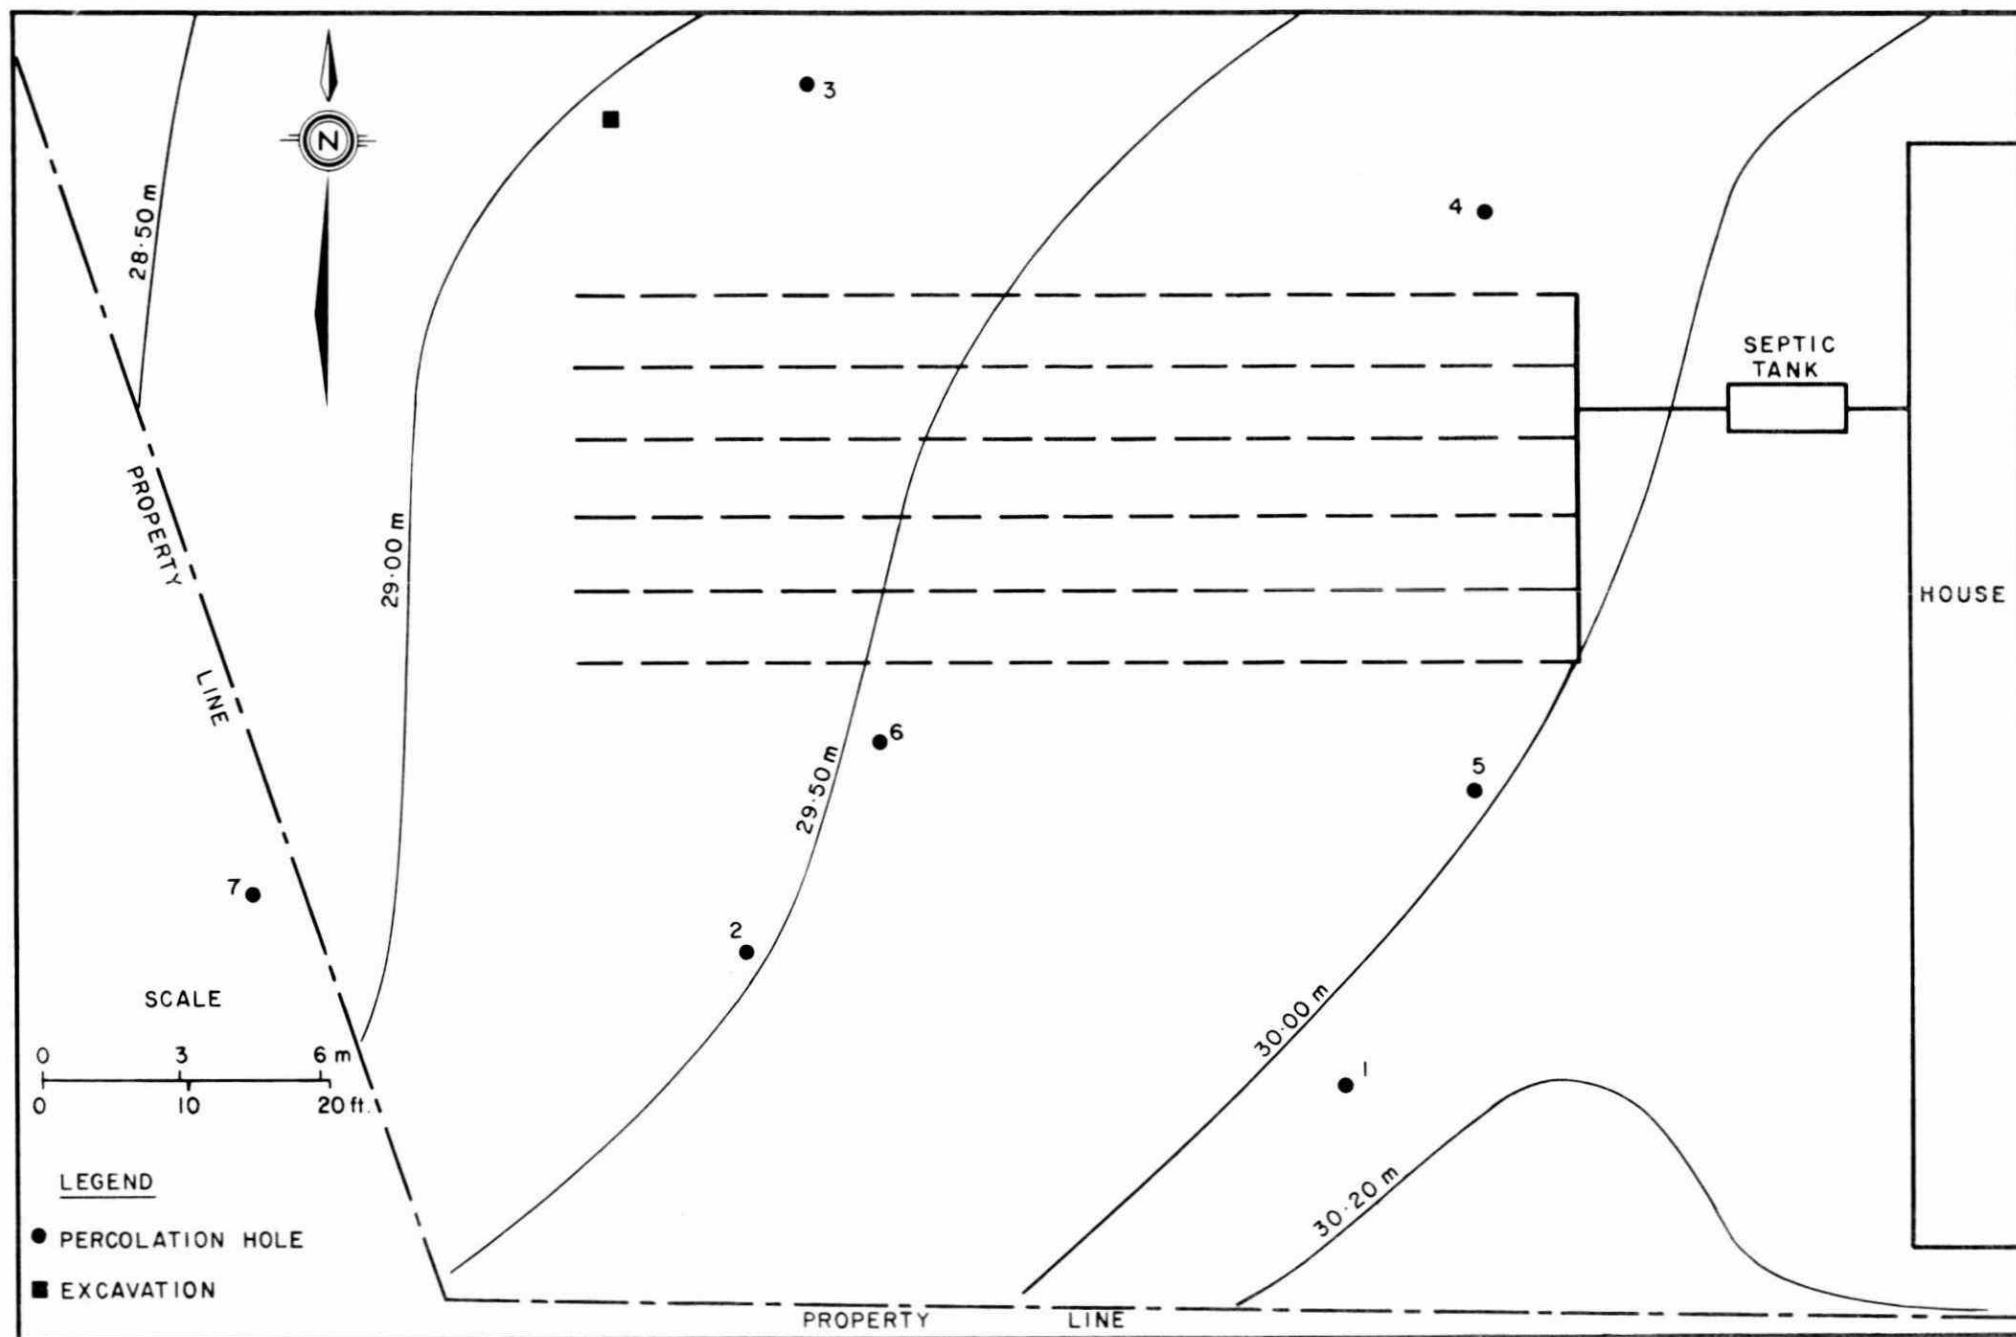
FIGURE 6: LAYOUT, TOPOGRAPHY AND LOCATIONS OF PERCOLATION HOLES AT SITE A3.

The tile field system on the lot functioned satisfactorily and at the time of the field investigation no sign of ponding of the septic tank effluent was ever observed. Several factors could be responsible for the

- (i) The surface drainage condition was good--the surface water was draining from the tile field area to the far end of the property line as shown by the contour lines in Figure 6.

- (iii) There were six percolation tests done at this site and holes 3 to 6 were located on both sides of the tile field. Holes 3, 4, and 5 gave a percolation time in excess of 40 min./cm (100 min./in.); however, hole 6 had a much smaller percolation time (i.e. 4 min./cm). The percolation data (Table 1) indicate a large variation of the drainage characteristics of the soil in and adjacent to the tile field. Because of the low loading rate ($16.6 \text{ L/m}^2/\text{d}$) over the tile field area, the average infiltrative capacity of the soil was sufficient to absorb the septic tank effluent.

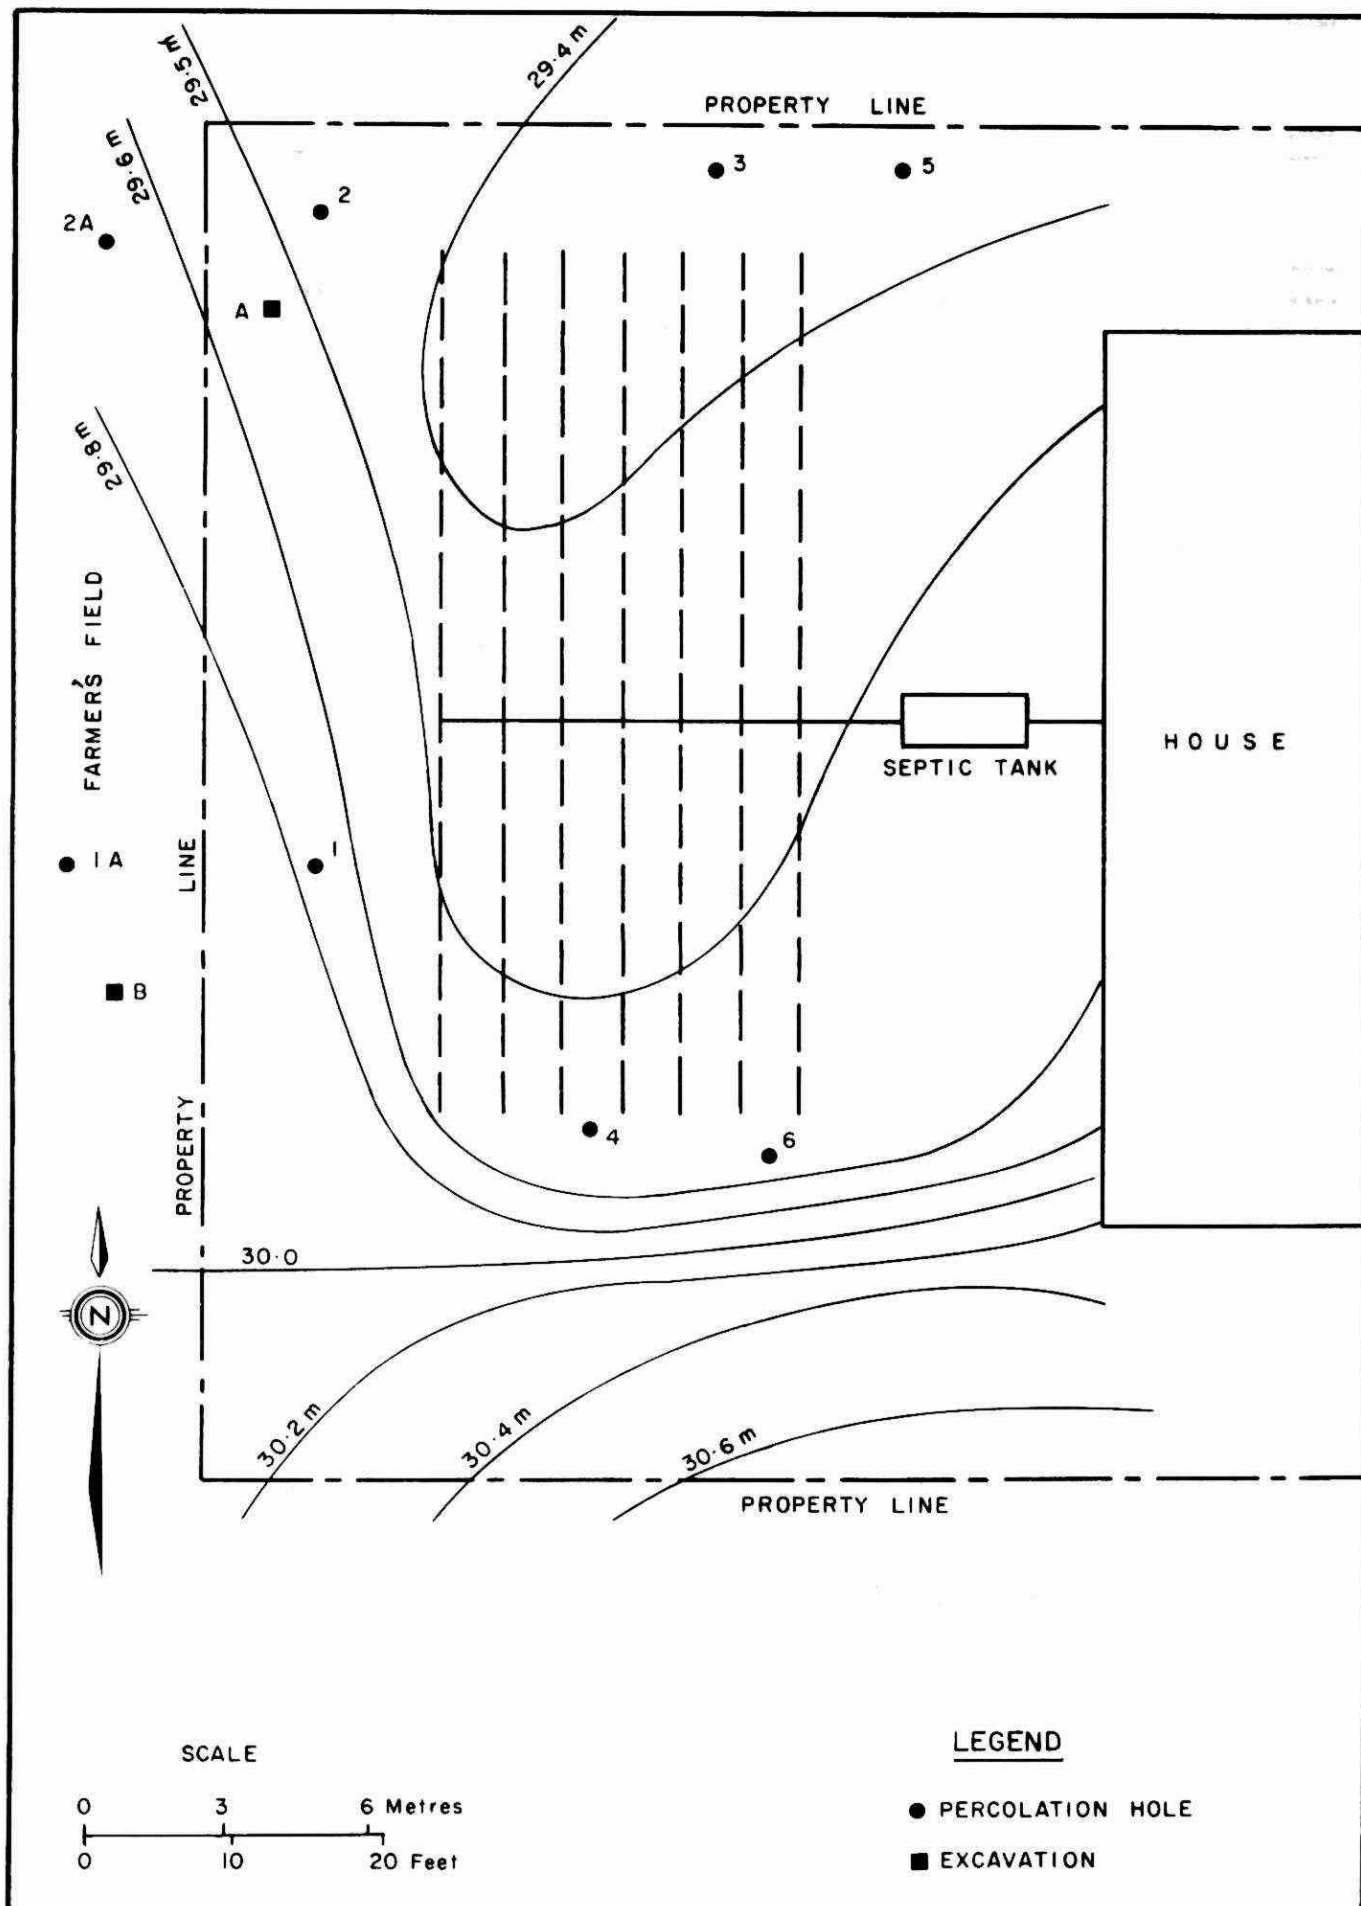
FIGURE 7: LAYOUT, TOPOGRAPHY AND LOCATIONS OF PERCOLATION HOLES AT SITE A4.

According to the on-site observations regarding the performance of the tile field, it can be concluded that the system failed during the wet seasons of the year even though the hydraulic loading rate on the tile field was low. The main factor for the failure was the relatively impermeable soil conditions, coupled with poor surface drainage. On the southside of the tile field the ground surface was about 1 m higher than the tile field area. During the spring season, the surface runoff would be flowing from the high

ground to the flat area, where the tile field was located. In the summer season, the tile field would work satisfactorily with the help of evapotranspiration under the warm climatic conditions.

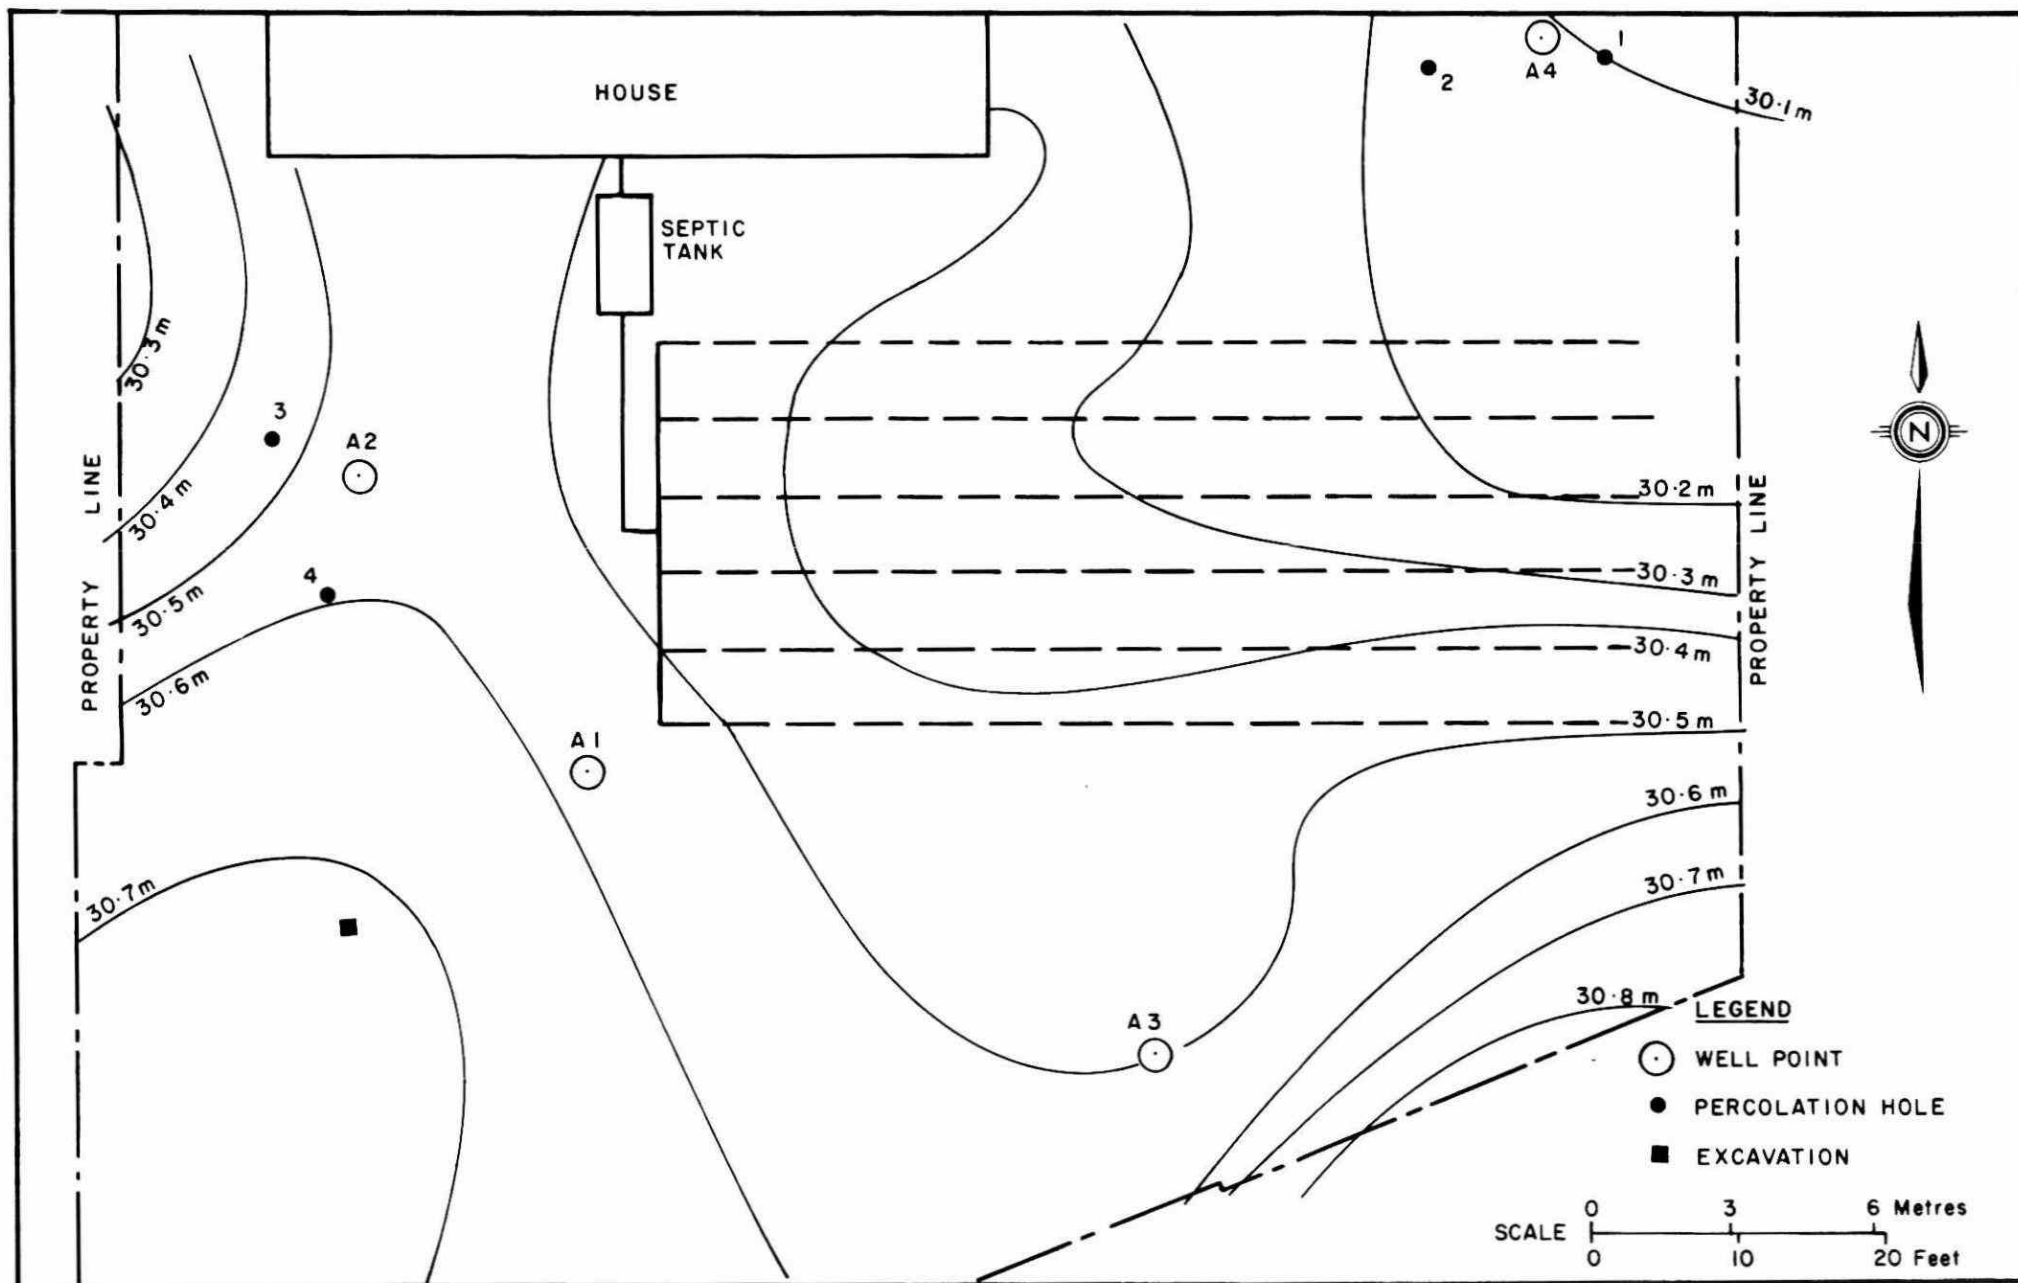
FIGURE 8: LAYOUT, TOPOGRAPHY AND LOCATIONS OF PERCOLATION HOLES AND WELL POINTS AT SITE A5.

A number of short copper pipe well points were installed above the tile trenches. Measurements of the water levels in these pipes were taken approximately once a month from May 1977 to October 1977. In May to July, the water level in the tile trenches was not greater than 0.2 m below the ground surface. In August to October, the water level was at the ground surface, i.e. the septic tank effluent was ponded on the ground surface. In the spring time in 1977, it was observed that the ground surface in the tile field area was very wet and soggy.

From the field observations, the tile field system did not function satisfactorily. Most of the time, the ground surface in the tile field area was wet and soggy indicating a severe surface ponding of septic tank effluent. The failure of the tile field was attributed to two main factors: (i) unfavourable soil conditions. (i.e. large percolation time and high percentage of clay in the soil); and (ii) poor surface drainage (i.e. water adjacent to the tile field was collected in the flat area where the tile field was constructed). As a result of the poor surface drainage at the site, the water table in the vicinity of the tile field was quite high, which would interfere with the flow of water from the tiles to the ground water system.

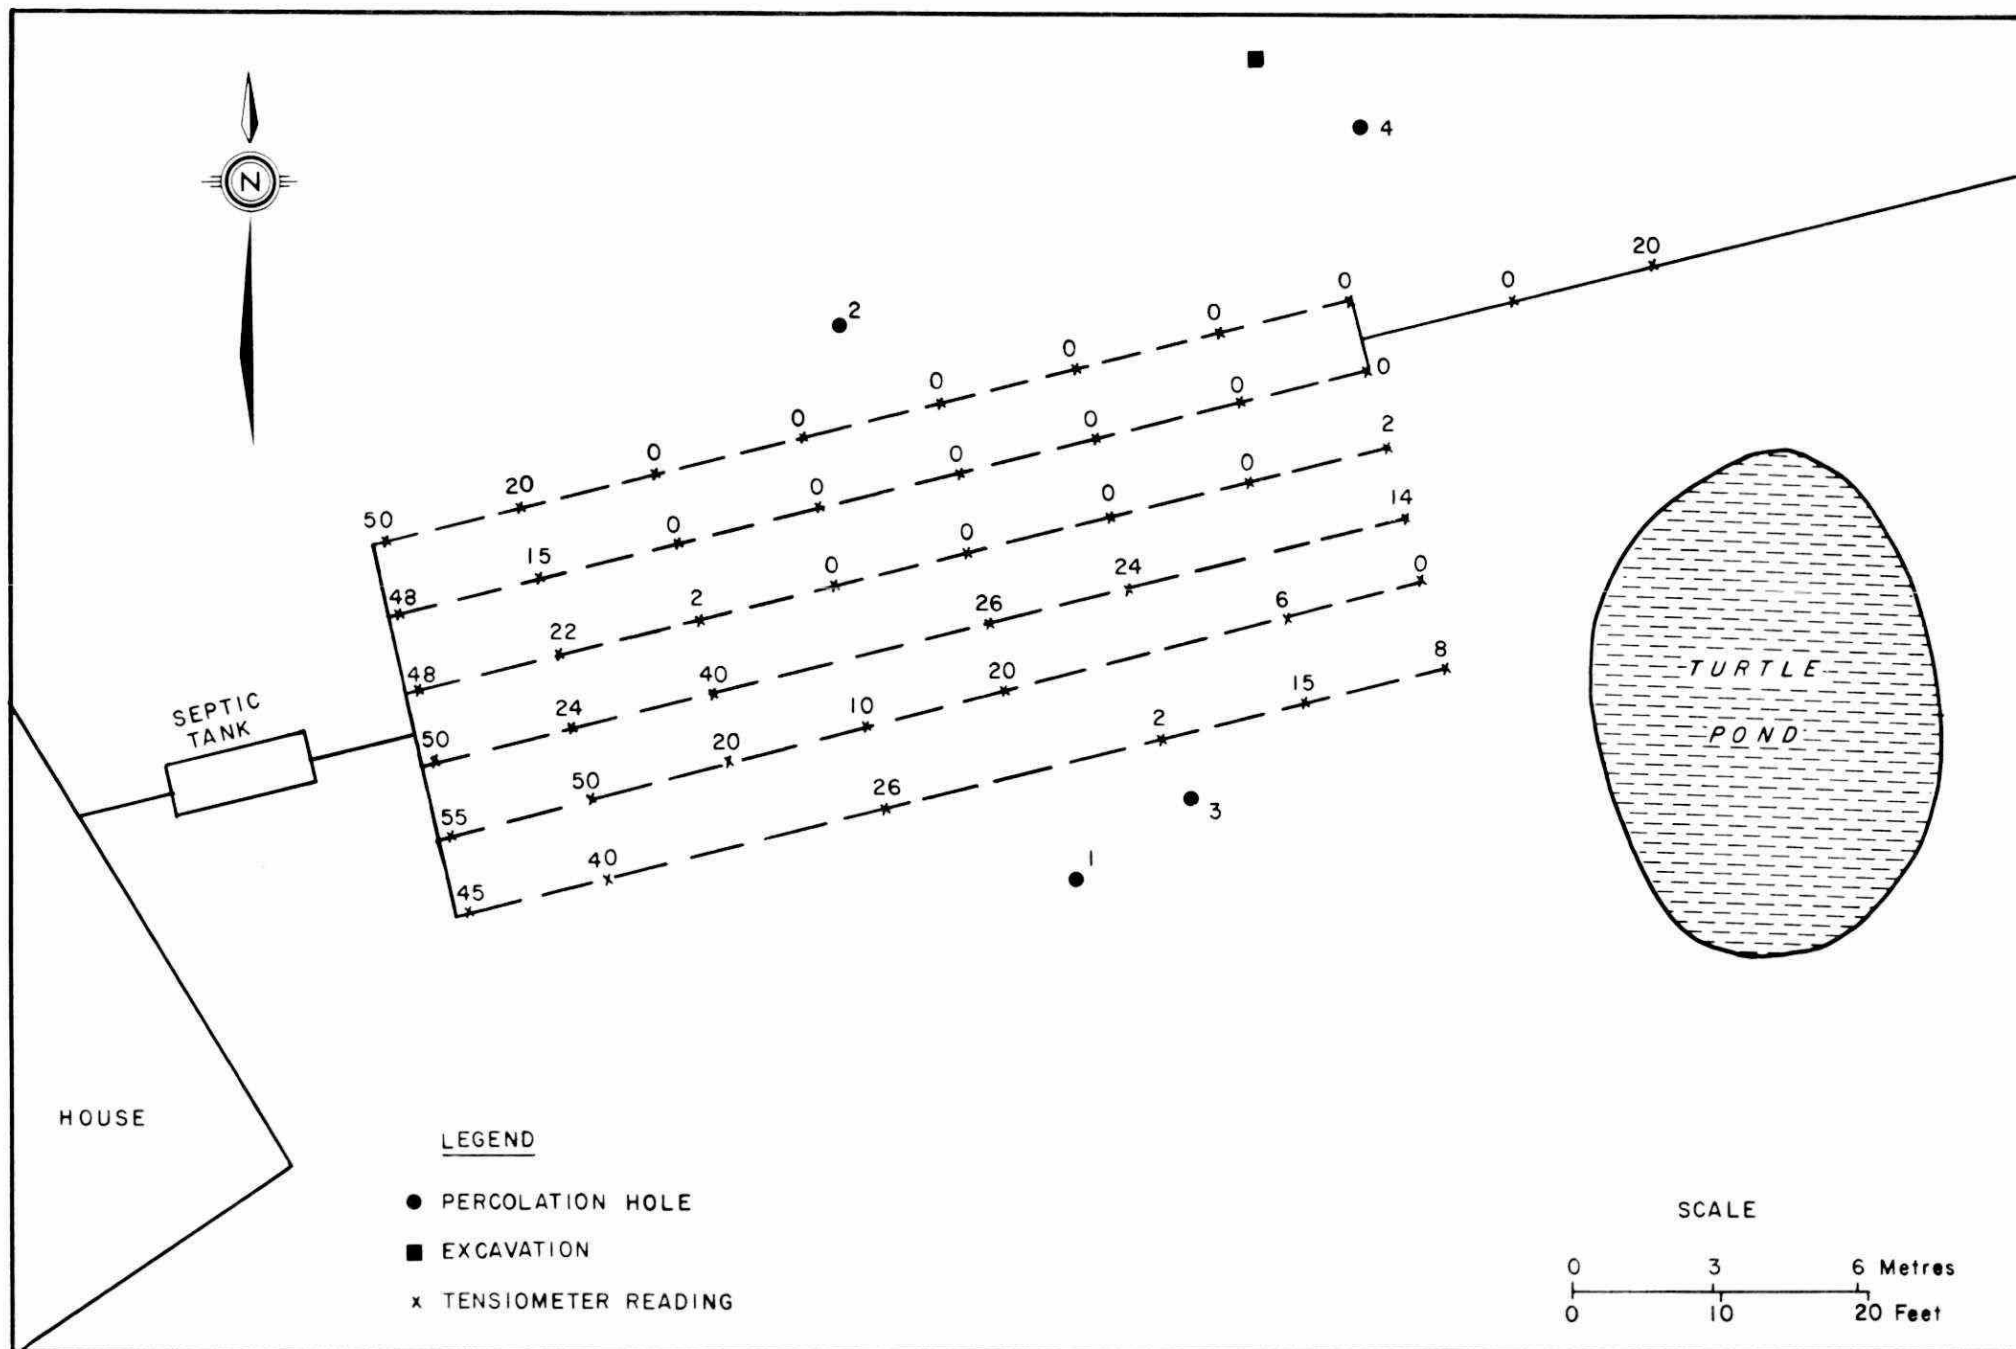
FIGURE 9: LAYOUT, LOCATIONS OF PERCOLATION HOLES AND TENSIO METER TEST READINGS AT SITE A6.

owner because he noticed that the ground surface above the two lines of tiles on the northside of the tile field was frequently wet (i.e. sign of ponding). According to the house owner, the additional line of tiles appeared to have alleviated the problem.

According to the house owner, the tile field appeared to be functioning satisfactorily. During field visits to the site, it was observed that the ground surface above the tiles was reasonably dry, with the exception that in late March 1977, the north portion of the tile field was wet on the ground surface. Block soil samples were taken from an excavation for the hydraulic conductivity tests. In the excavation, it was found that there was a thin layer of top soil with dead grass at the depth of 0.6 m (2 ft.), which indicated that the soil above 0.6 m was probably a fill material. Below the top soil layer at the depth of 0.6 m, there was about 0.3 m of clayey silt with some organic material, which was underlain by a very dense clayey silt soil. The hydraulic conductivity results are summarized in Table 2.

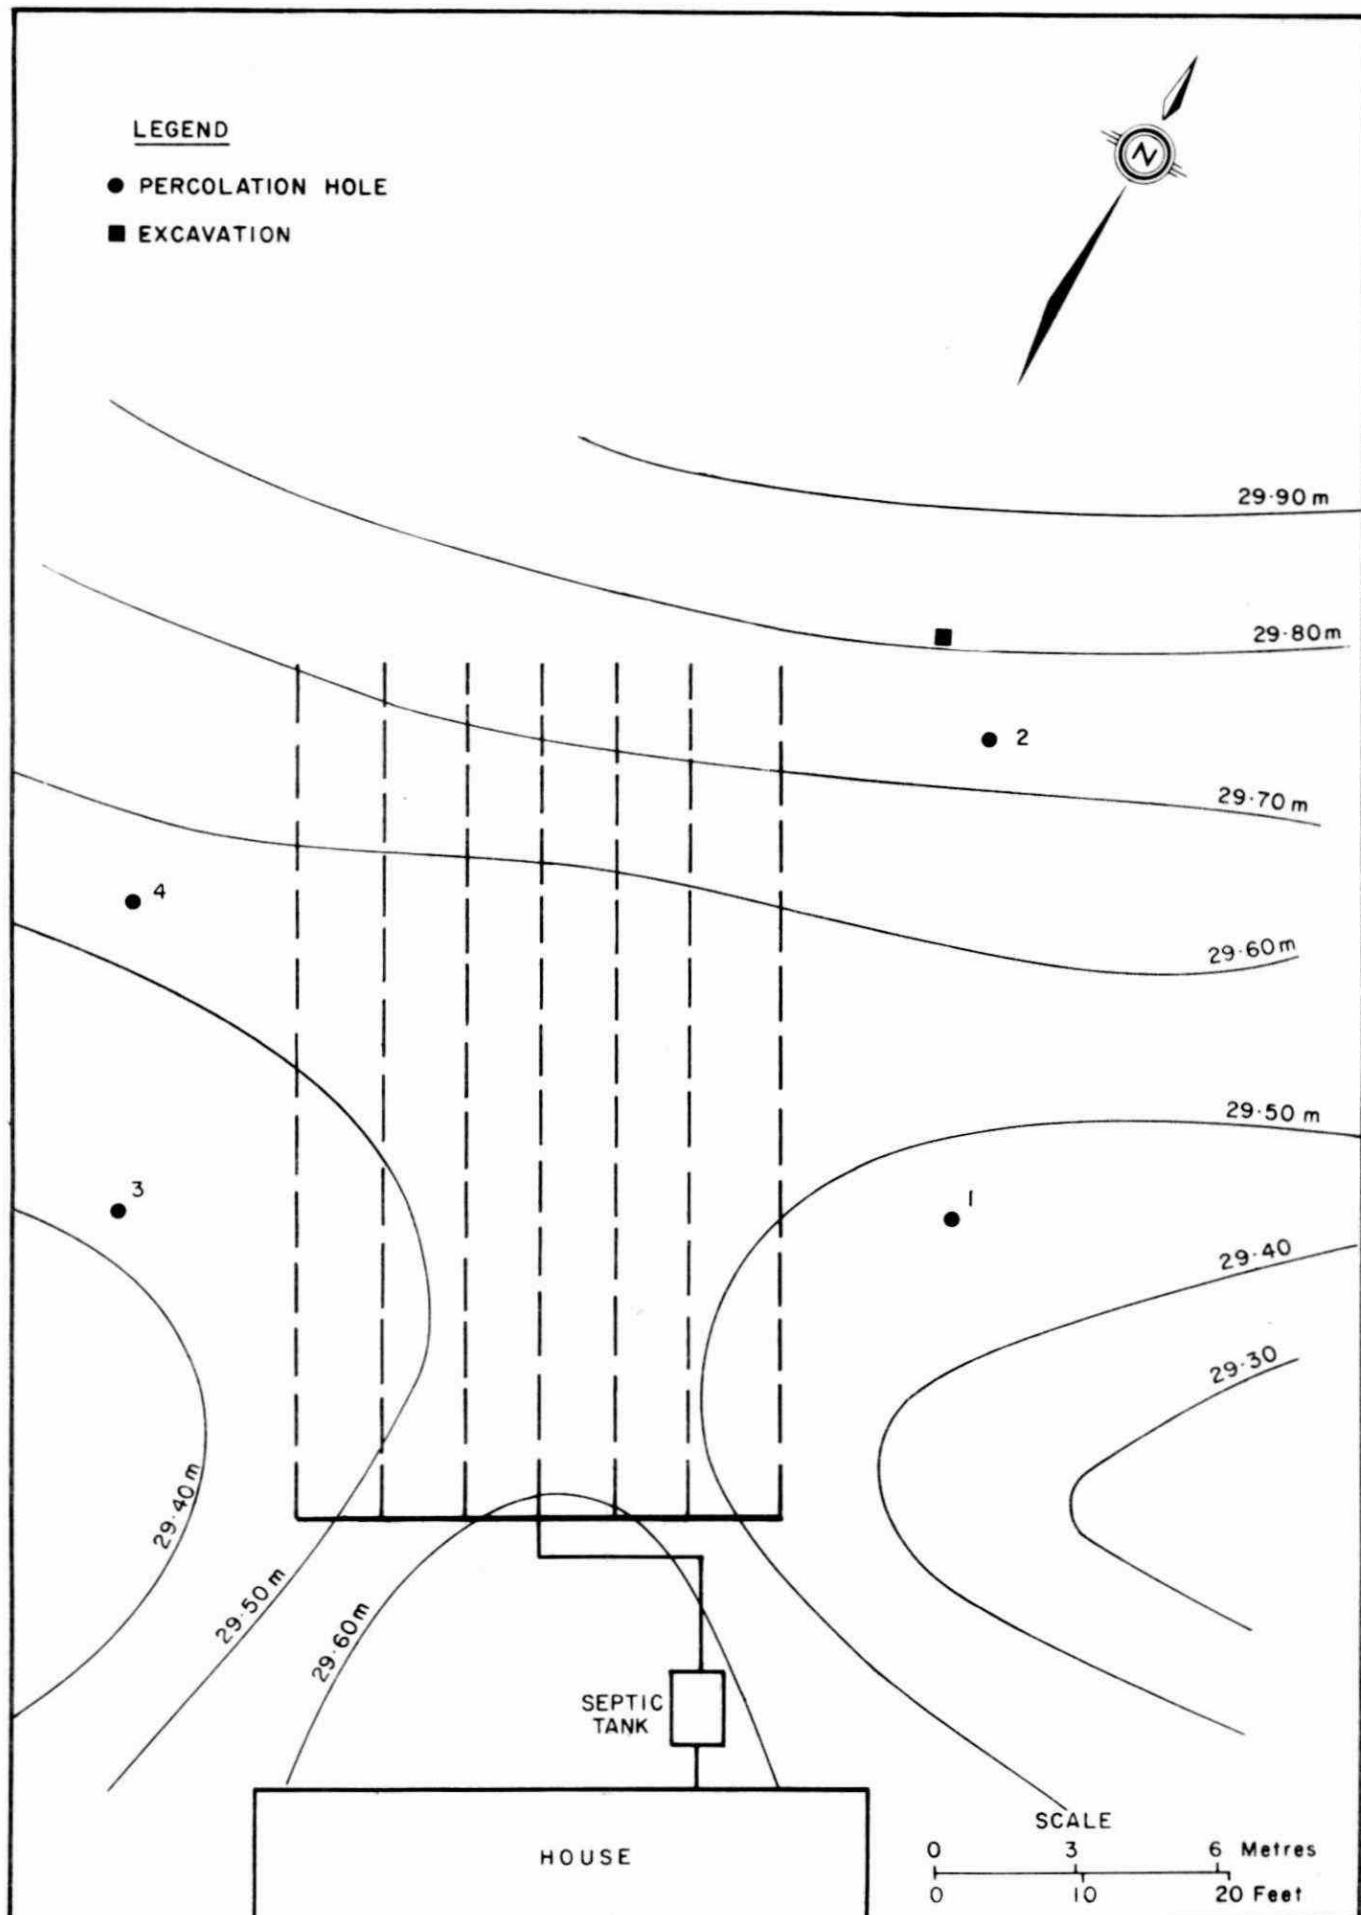
FIGURE 10: LAYOUT, TOPOGRAPHY AND LOCATIONS OF PERCOLATION HOLES AT SITE BI.

The layout of the tile field and ground surface contour lines are shown in Figure 10. The depth of the tiles was approximately 0.7 m (2.2 ft.) below the ground surface, which was relatively flat with surface drainage in the east and west direction. The well points installed on the site indicated that the water table was more than 1.1 m (3.8 ft.) below the ground surface during July to November 1977. The small copper well points installed above

the tile trenches were dry during the monitoring period (July to November 1977), indicating the soil had sufficient absorptive capacity for the septic tank effluent at the time of field study.

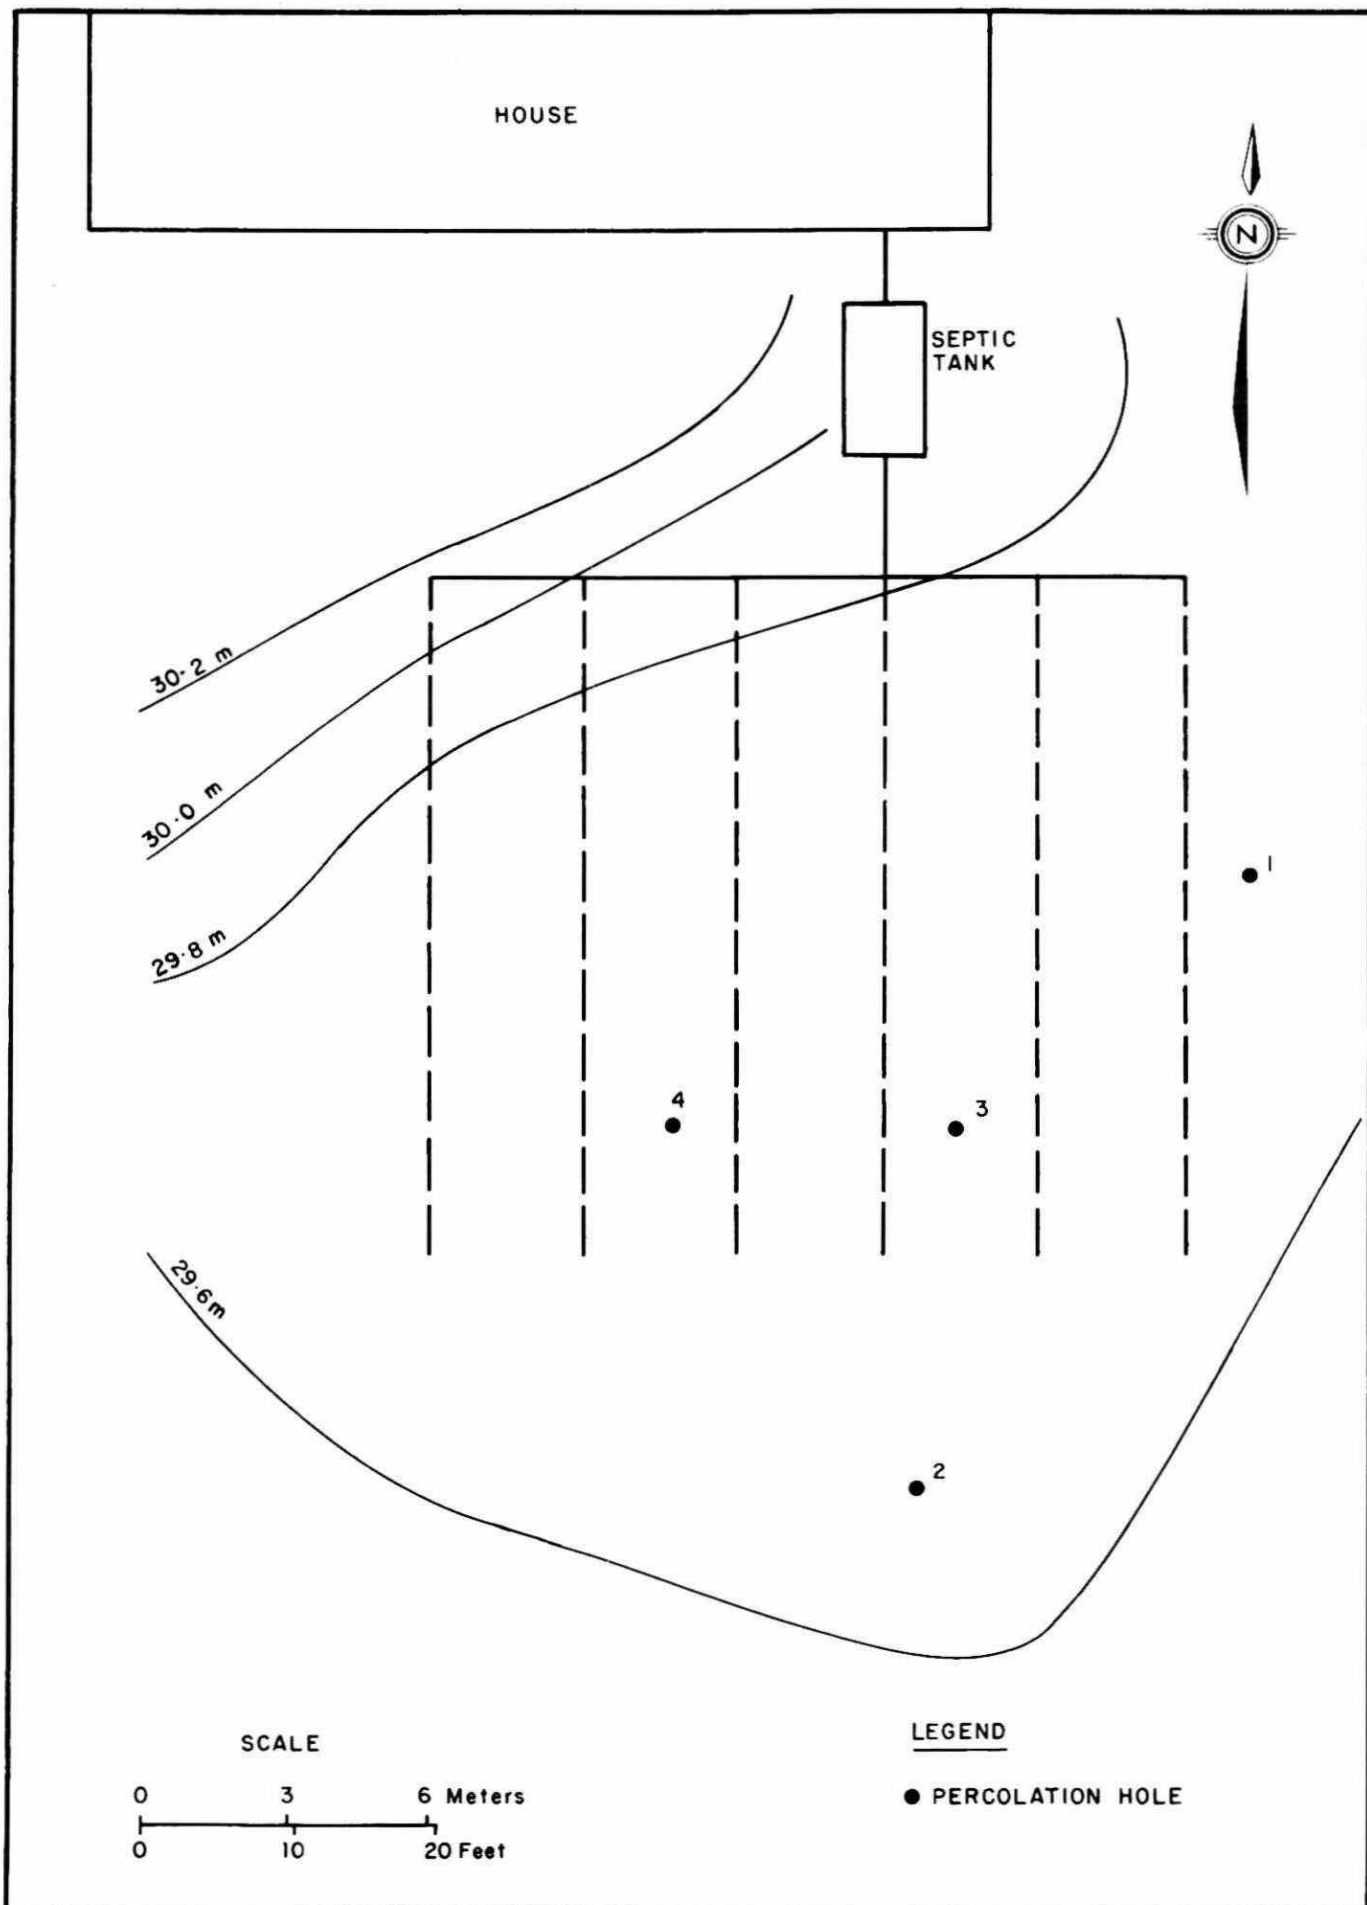
FIGURE 14; LAYOUT, TOPOGRAPHY AND LOCATIONS OF PERCOLATION HOLES AT SITE MI.

The waste disposal system was installed by a contractor in 1967 and consisted of a cast iron septic tank and six rows of clay tiles (Figure 14). It was not possible to find any information on the design and the capacity of the tank. The tiles were located between rows of apple trees and were 46 cm (18 in.) below the ground surface. The length of each row of tiles was 13.7 m (45 ft.) giving a total length of 82.3 m (270 ft.) for all six rows. The

During the field investigation period, it was found that the soil in the tile field had adequate adsorptive capacity for the septic tank effluent. This conclusion was derived from field observations of the ground surface in the tile field area and information from the owner of the house. The operational success of the tile field was probably due to the relatively low hydraulic loading rate and reasonably good drainage characteristics of the soil (percolation time less than 24 min./cm).
